Manhole Inspection Summary

Manhole # S13Q__029MH

Insp Date: **3/18/08 12:50 PM**

Location Address: **2804 Wilkens Ave**

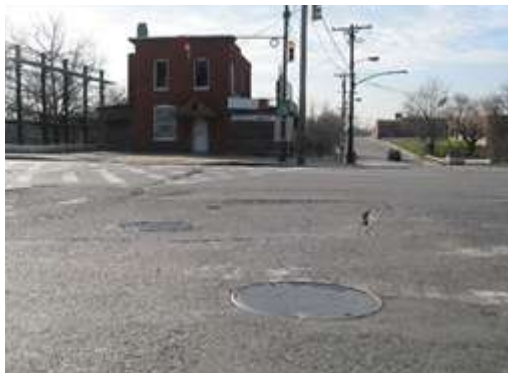
Location View

cover worn

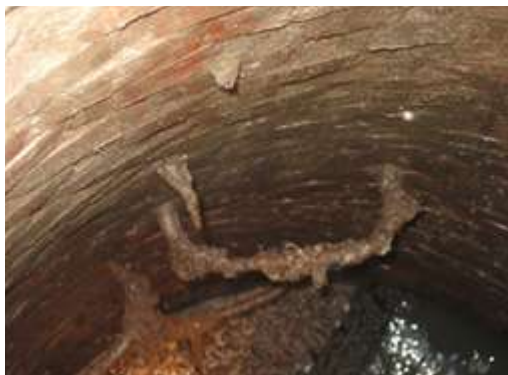
Defect 5

signs of surcharge missing rung/ Barrel infiltration

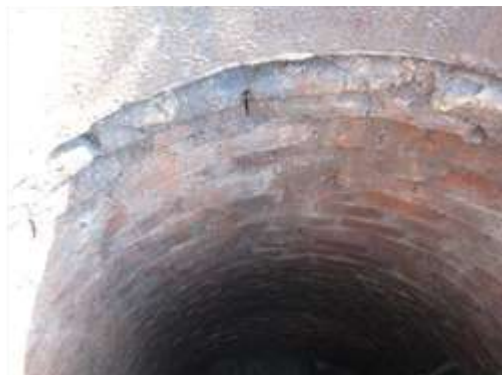
Defect 2

loose bricks chimney infiltration at wall

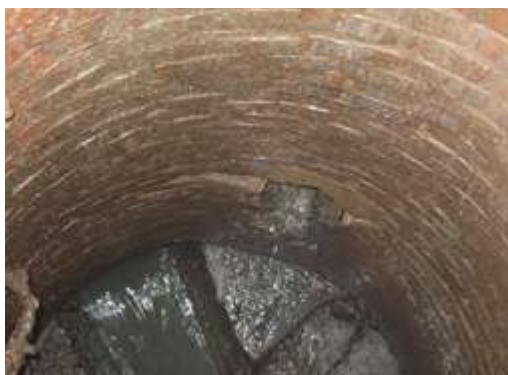
Defect 3

missing bricks at 6 oclock connection

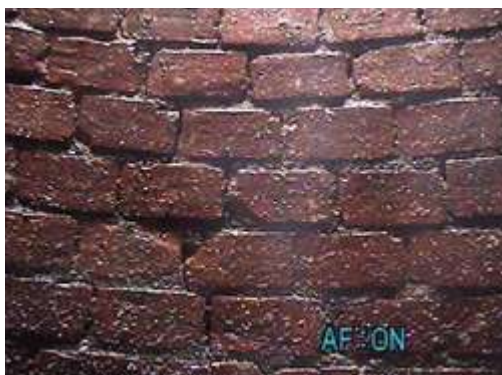
Defect 1

barrel wall infiltration

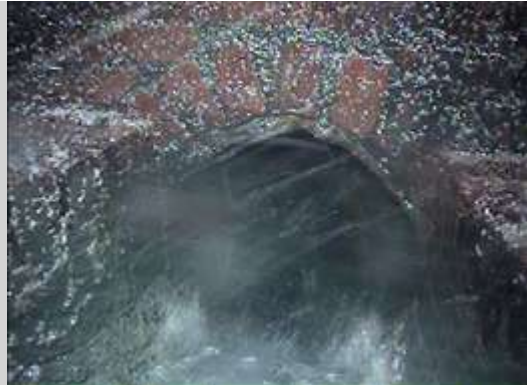
12 O'Clock Outflow

Pipe Height: **16.8** (in.) Rod and Bar (Angled)
Pipe Material: **Clay** ☐ Pipe Lined
Invert Depth: **10.56** (ft.) Flow Characteristics: **Turbulent**
Deposits: ☒ None ☐ Mud ☐ Sludge ☐ Debris ☐ Grease
Silt Depth: **0** (in.) Deposits Extent:
Infiltration: **Evidence** Pipe Seal Cond: **Unknown**

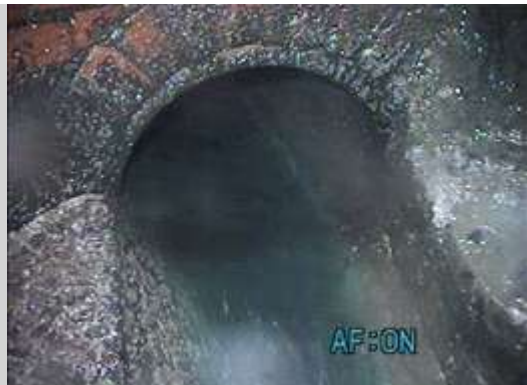
5 O'Clock Inflow

Pipe Height: **16.8** (in.) Rod and Bar (Angled)
Pipe Material: **Clay** ☐ Pipe Lined
Invert Depth: **10.18** (ft.) Flow Characteristics: **Turbulent**
Deposits: ☐ None ☒ **Mud** ☐ Sludge ☐ Debris ☐ Grease
Silt Depth: **0** (in.) Deposits Extent: **Light**
Infiltration: **Evidence** Pipe Seal Cond: **Unknown**

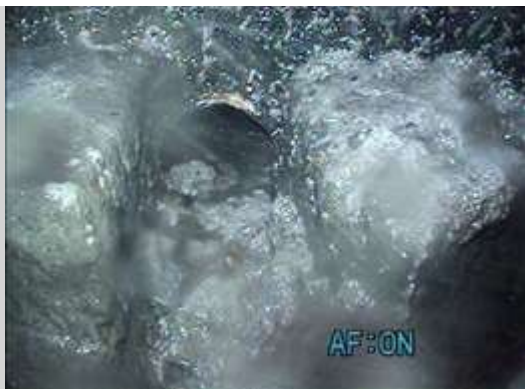
7 O'Clock Inflow

Deposits: ☐ None ☐ Mud ☒ **Sludge** ☐ Debris ☐ Grease

Silt Depth: **2** (in.) Deposits Extent: **Light**

Infiltration: **Evidence**

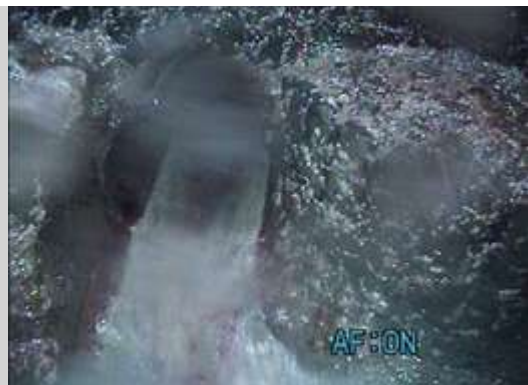
9 O'Clock Inflow

Infiltration: **Evidence** Pipe Seal Cond: **Sound**
